# **INDOOR AIR QUALITY ASSESSMENT**

**Department of Early Education & Care  
326 Clark Street  
Worcester, Massachusetts**

Prepared by:  
Massachusetts Department of Public Health  
Bureau of Environmental Health  
Indoor Air Quality Program  
January 2019

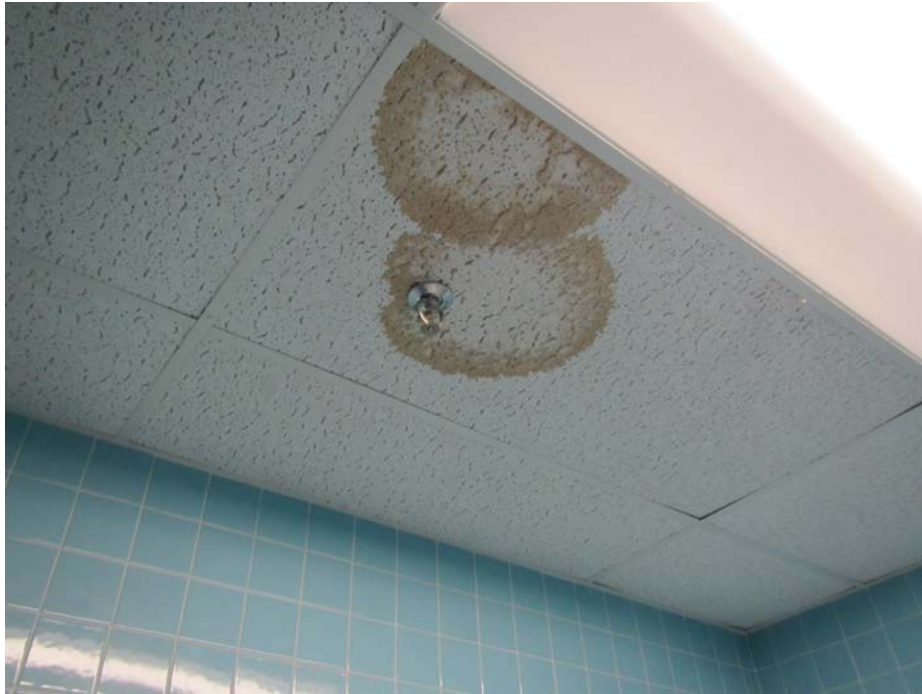
**Picture 1**

Two water-damaged ceiling tiles were noted in the men's bathroom during this assessment (Picture 1). Porous building materials (e.g., carpeting, gypsum wallboard, ceiling tiles) that are not dried within 24 to 48 hours of being wet may support mold growth and should be discarded. Repairs should be made to stop any active leaks.

**One of two water-damaged ceiling tiles found in the men's room**

1. Operate the HVAC system to provide for continuous fresh air ventilation during occupied hours. Inspect all thermostats to ensure that they are set for “fan on” instead of the “auto” setting.
2. Discard water-damaged ceiling tiles in men’s bathroom and replace. Make repairs as necessary if there is an active water leak in this area.
3. Replace any missing ceiling tiles (e.g., reception area) and ensure they are all seated properly in the ceiling tile grid.
4. Reduce or eliminate the use of scented cleaners, hand sanitizers, and personal air fresheners.
5. Property management/contractors should consult the MDPH guideline: “[Construction and renovation generated pollutants in occupied buildings](#)”. Implement the recommended isolation/depressurization strategies during active renovation projects. Any pathways that

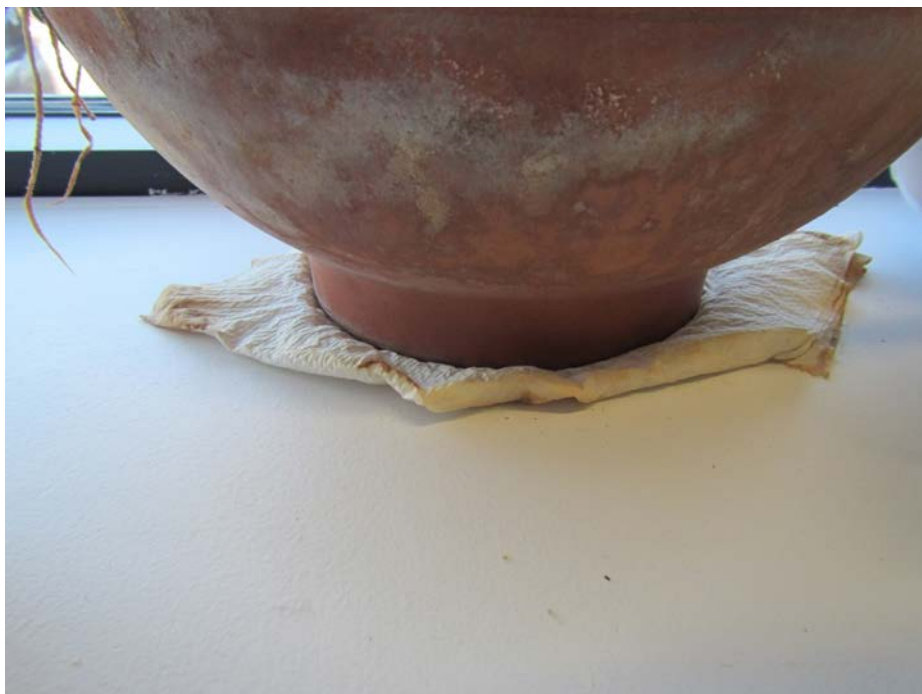
**Picture 2**

There were a large number of plants in occupied areas (Table 1). Some of these plants were on porous items, lacking waterproof drip pans, or growing against porous building materials (Pictures 2 and 3). Plants can be a source of odors, pollen and mold. Plants should be kept in good condition, not overwatered, and not placed on porous materials.

**Plant placed on water-damaged/porous material**

7. Properly maintain plants, including drip pans, to prevent water damage to porous materials. Plants should also be located away from air diffusers to prevent the aerosolization of dirt, pollen, and mold. Consult the MDPH guideline “[Indoor Plants and Indoor Air Quality](#)” to avoid problems associated with improper plant maintenance.

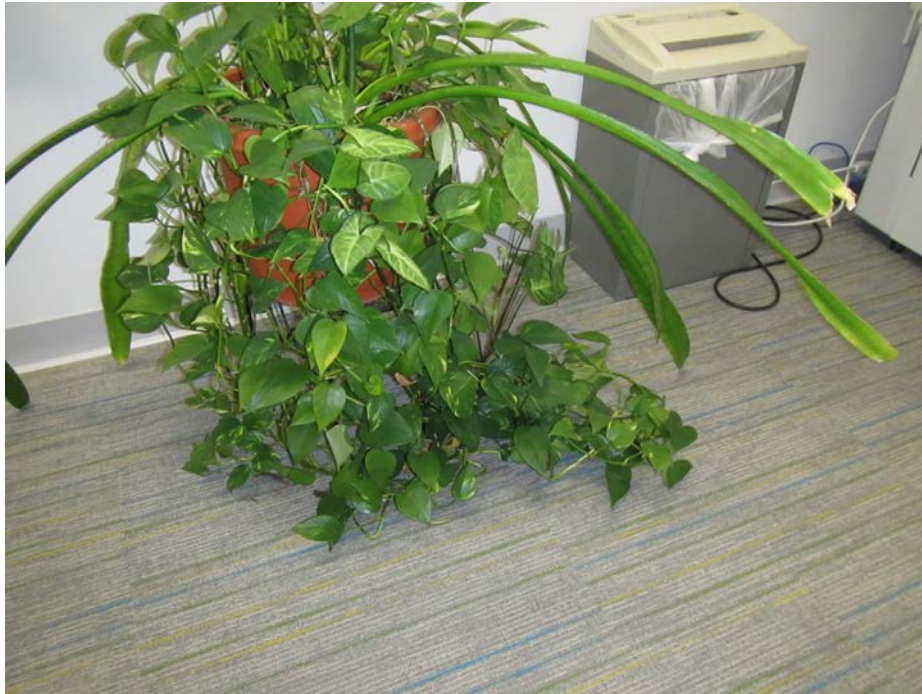
**Picture 3**

**Overgrown plant over porous carpeting**

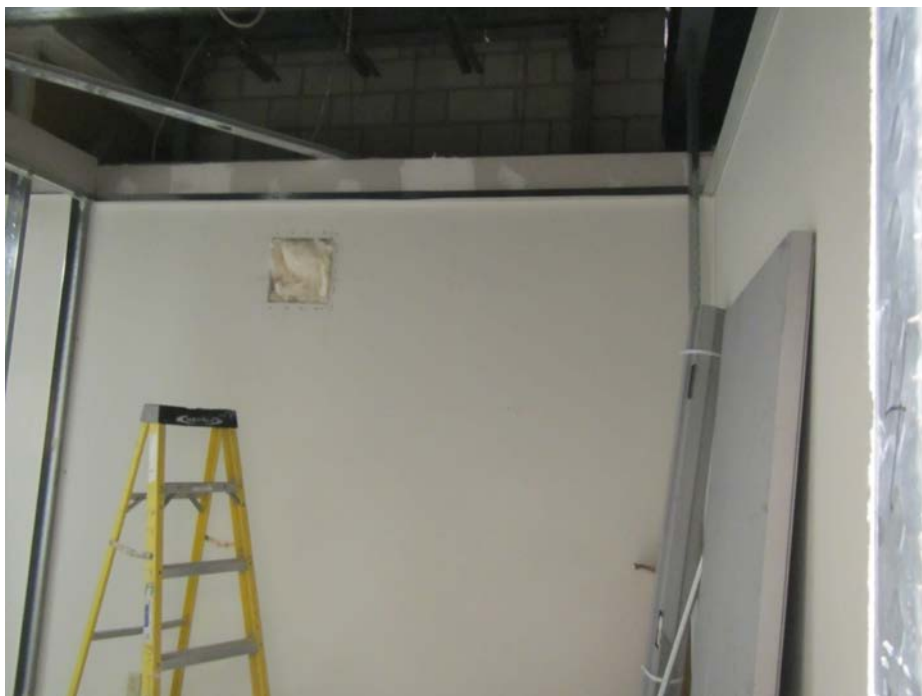
**Picture 4**

The second floor (above the EEC space) was being actively renovated at the time of this assessment. Some gaps between the EEC-occupied space and the area under construction were observed (Pictures 4 and 5). These pathways may allow construction odors and particulates into the space if they are not properly sealed.

**Active renovations in room off of EEC hall and 2<sup>nd</sup> floor above**

lead from the construction area to the EEC space should be sealed. This would include pathways that lead to the ceiling plenum.

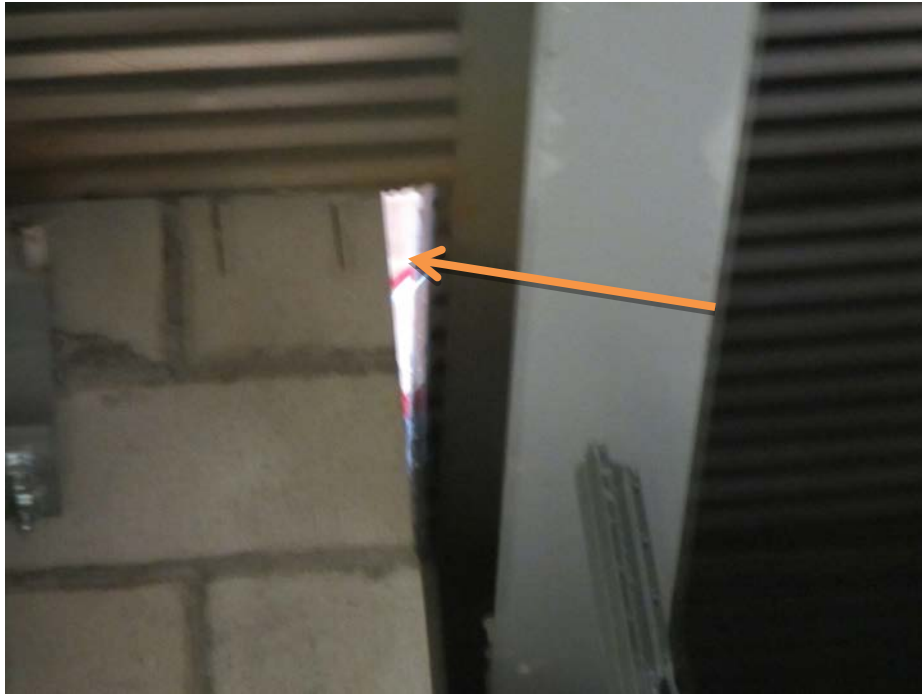
**Picture 5**

**Pathways leading to 2<sup>nd</sup> floor active renovations**

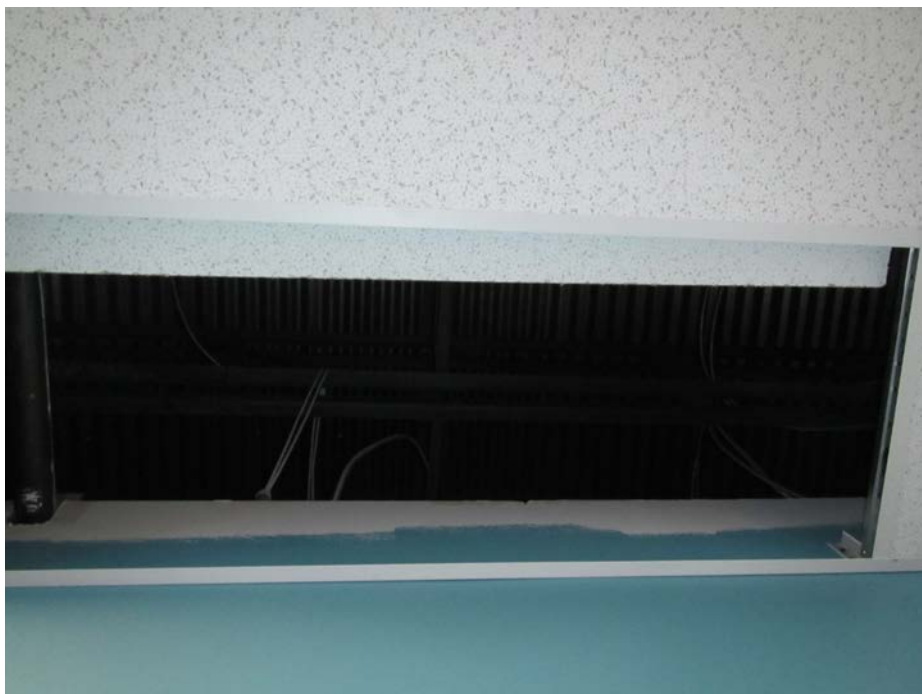
**Picture 6**

BEH staff noted one missing ceiling tile in the public reception area (Picture 6). All ceiling tiles should be replaced and seated properly in the ceiling grid to avoid the migration of odors and particulates from unconditioned spaces.

**Ceiling tile not in place within ceiling grid of reception area**
